USACERL Special Report 99/01
October 1998

Shear Strengthening of Reinforced Concrete Beams Using Fiber-Reinforced Polymer Wraps

Pamalee A. Brady and Orange S. Marshall

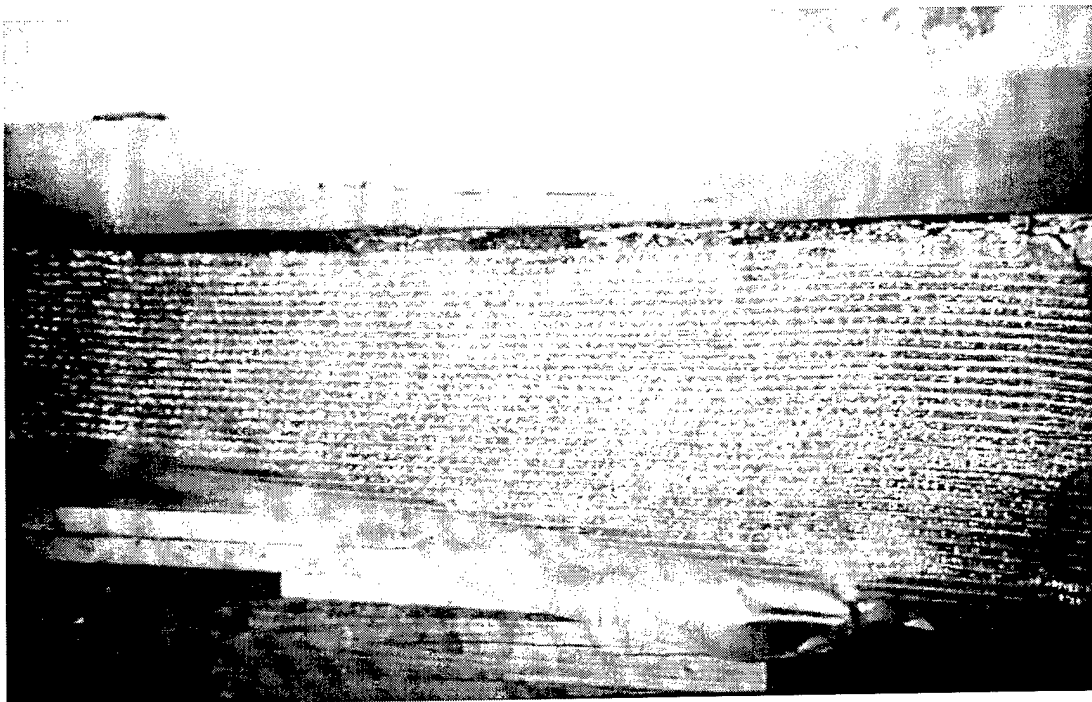
Figure 10. Gap in FRP upgrade of HJ-3.

shear mode failure of HJ-3 was initiated by a gap on the joist web where the FRP had slipped during curing. Its performance was not improved over HJ-6.

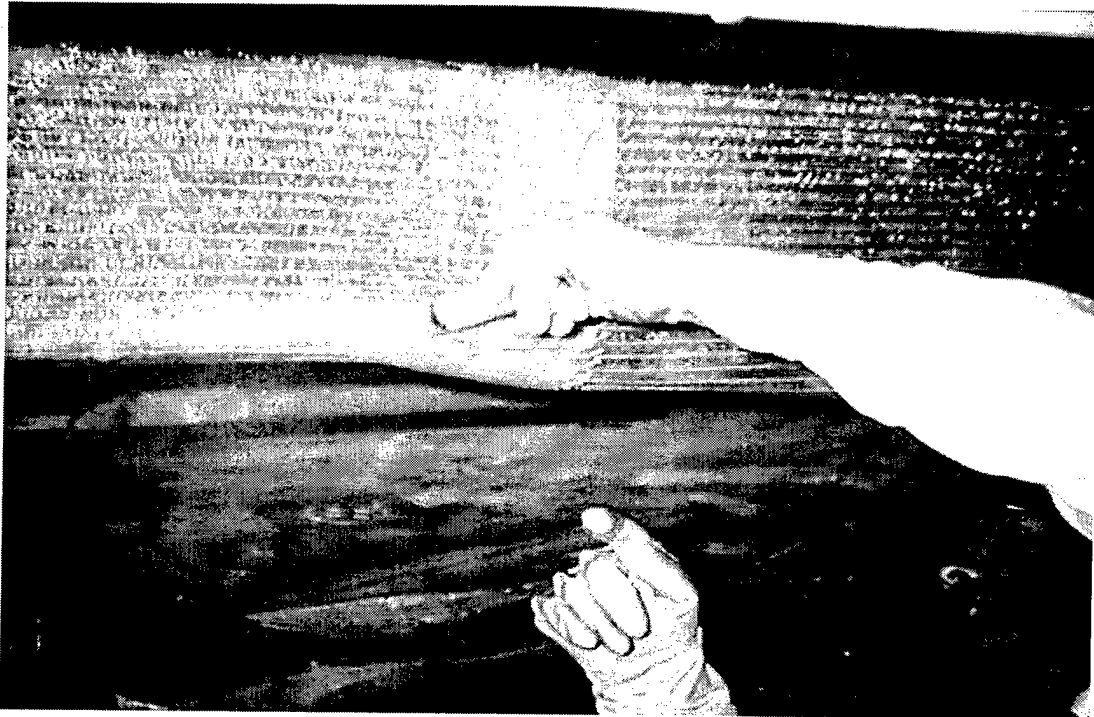
Figure 11. Epoxy injection of voids.

Because of lack of Cab-O-Sil™ in the tack coat, the system applicators had great difficulty getting the FRP system to adhere properly to the concrete prior to curing. The cure time was also slow because of high humidity. Upon cure it was noted that the FRP had slipped down on both HJ-3 and HJ-4. A gap, uncovered by FRP, existed beneath the bottom of the slab on the web. In most locations the gap was not significant; however, on the north end of HJ-3 the gap was observed to be 1.25 in., Figure 10. After curing, voids between the composite and the joist were filled with epoxy, Figure 11.

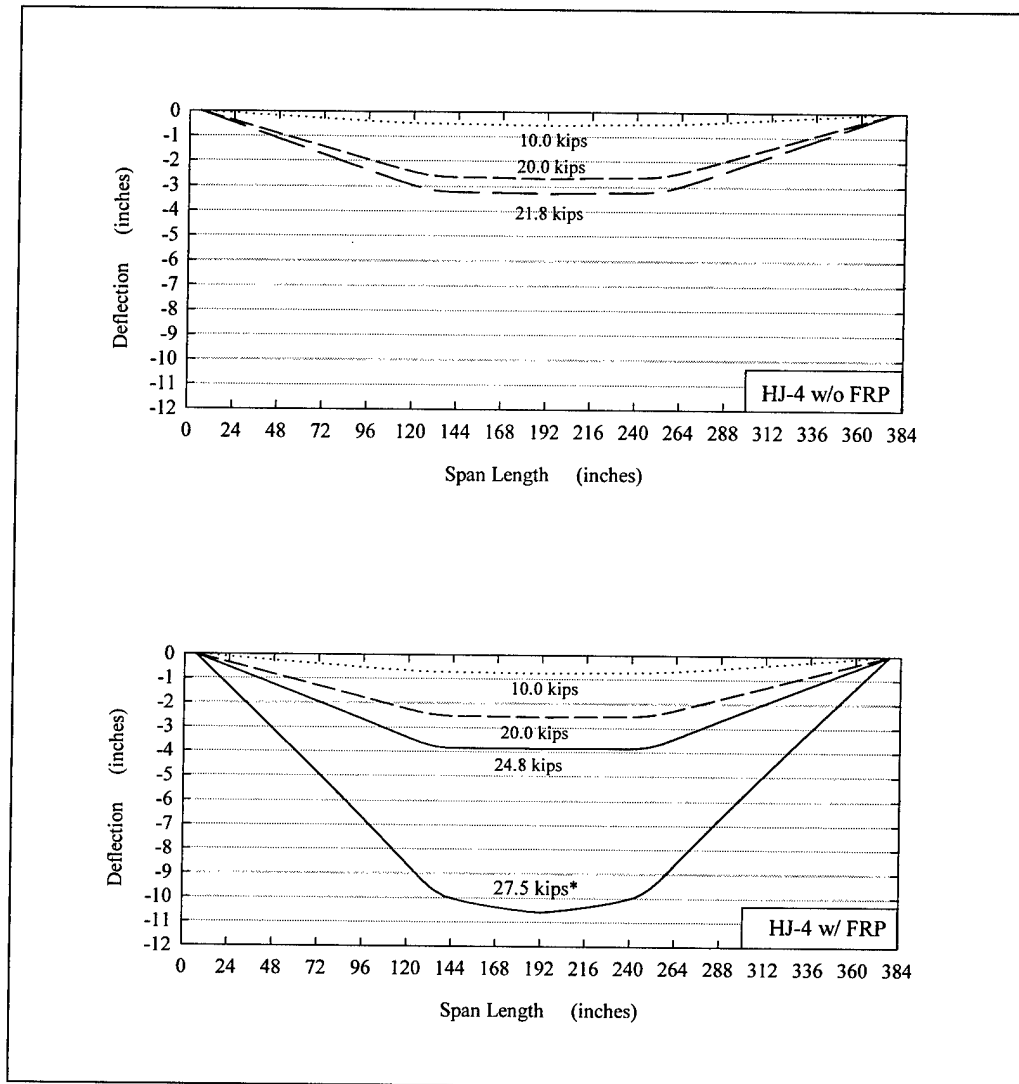
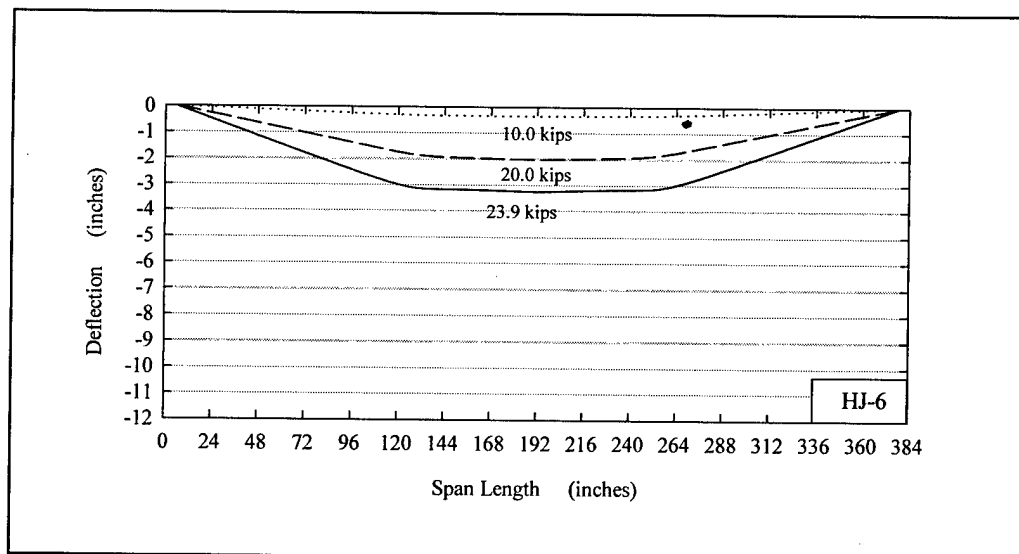
Deflection profiles along the joist length were approximated using potentiometer data as well as manual measurements from the joists' top flanges. A deflection profile is shown for HJ-3 with respect to load increments of a single actuator in Figure 21. Figure 22 shows deflection profiles for HJ-4 prior to repair and after the joist was repaired with FRP. HJ-3 deflected more than either the original or repaired HJ-4 for comparable load levels up to 25 kips. It also deflected much more than HJ-6. Similar plots for the other tested joists are shown in Figures 23 and 24. HJ-4, while able to deflect significantly was not able to match the performance of HJ-7. The shapes of HJ-3 and HJ-4 are much like that of the control joist, HJ-7. The shapes reflect the constant moment between load points and the

marked stiffness variation along the specimen length. The increased curvature with increasing load also reflects progressively greater cracking in the center section of the joists. The deflected shape of HJ-6 emphasizes the effects of insufficient shear reinforcement in the joist's inability to benefit from the prestressing and optimized shape.

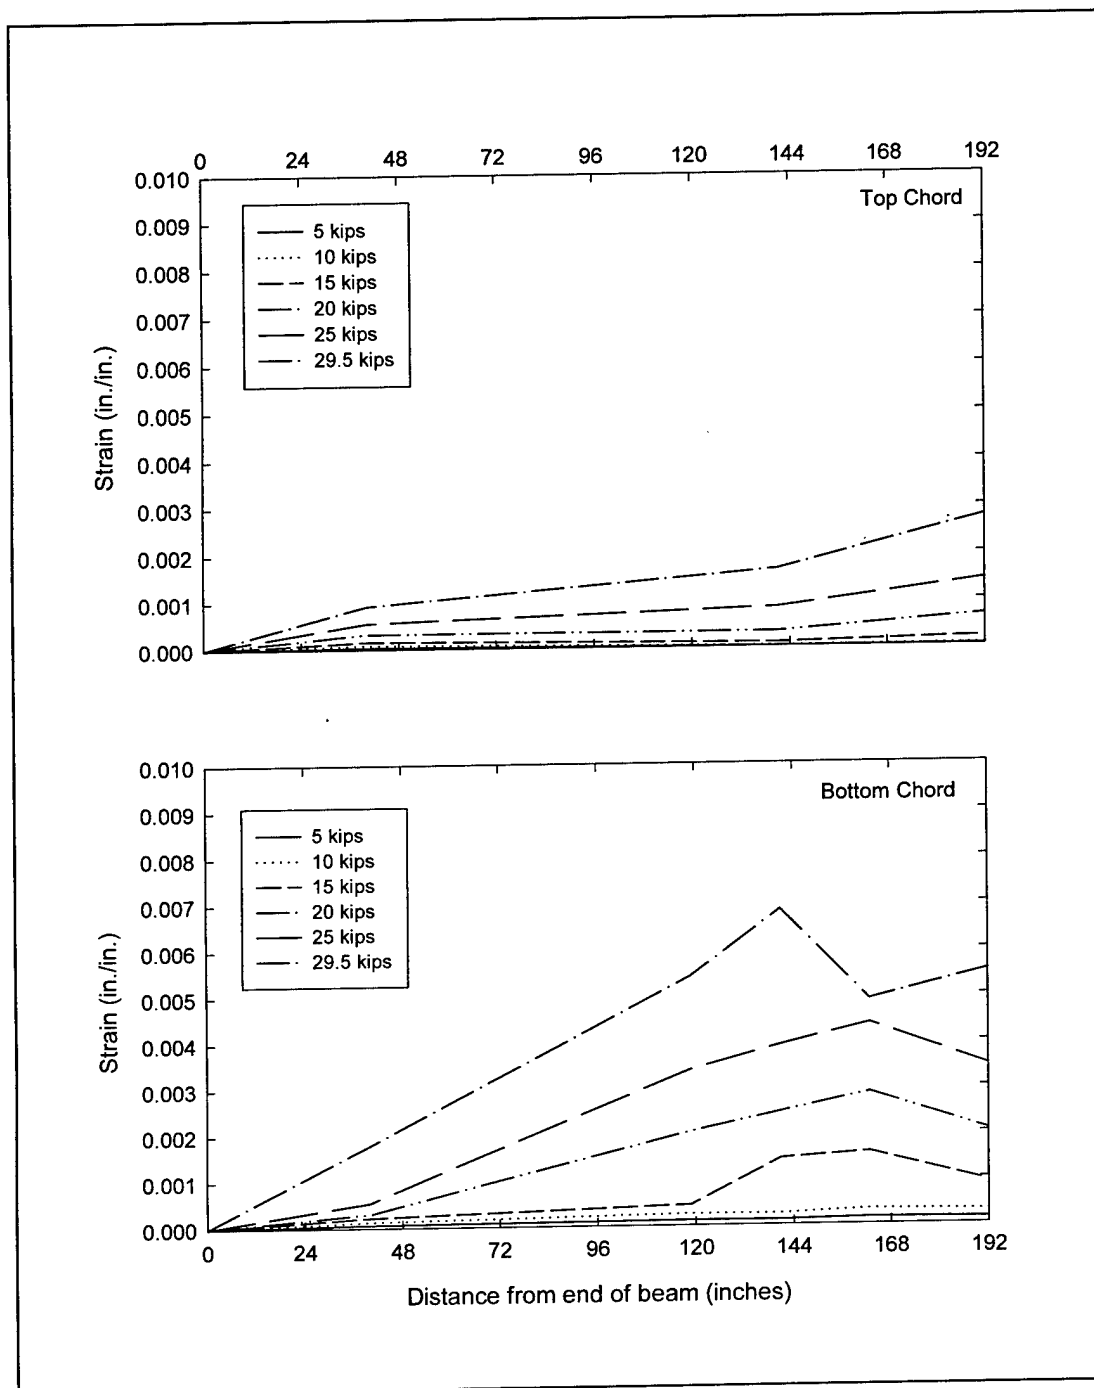
Strain distribution over section depth is shown in Figures 25 and 26 for three critical sections of HJ-3 and HJ-4 with FRP repairs. The distribution was approximated from concrete strain measurements near the top of the section and prestressing strand strains above and below the openings. Similar plots are shown in Figures 27 and 28 for HJ-6 and HJ-7, respectively. Strain along prestressing tendon length is shown in Figures 29 and 30 for HJ-3 and HJ-4 respectively. Figures 31 and 32 show strand strain measurements for HJ-6 through HJ-7.

Comparing Figures 26, 25, and 28, strain distribution in the repaired joist HJ-4 is quite different from that of either HJ-3 or HJ-7. The neutral axis indicated by the midspan strain is located at the member midheight. Peak strains in top and bottom prestressing strands of HJ-4 were greater than those in HJ-7, Figure 30 versus Figure 32. However, strain distribution over bottom tendon length is

To assess the stress in the strands, the strains shown must be added to the strain due to prestressing and related to the elastic modulus of the material. The strand was fully tensioned, so the effective strain due to the prestress is approximately 6705 micro strain $[(f_{se}/E_s) = 0.75 (270) / (30,000) (10^6) = 6750 \text{ micro strain}]$. All strains were below the ultimate strand strain of 35,000 micro strain. Again, the lack of strain developed in the strand indicates the poor performance of HJ-6. During testing it was observed that the bottom chord of HJ-7 appeared to arch upward between the struts; this may be related to the larger strains shown at the struts than the midspan for some load levels.
